INDOOR AIR QUALITY ASSESSMENT

**Williamsburg Town Office Building
147 Main Street
Williamsburg, Massachusetts**

Prepared by:
Massachusetts Department of Public Health
Bureau of Environmental Health Assessment
Emergency Response/Indoor Air Quality Program
January 2003

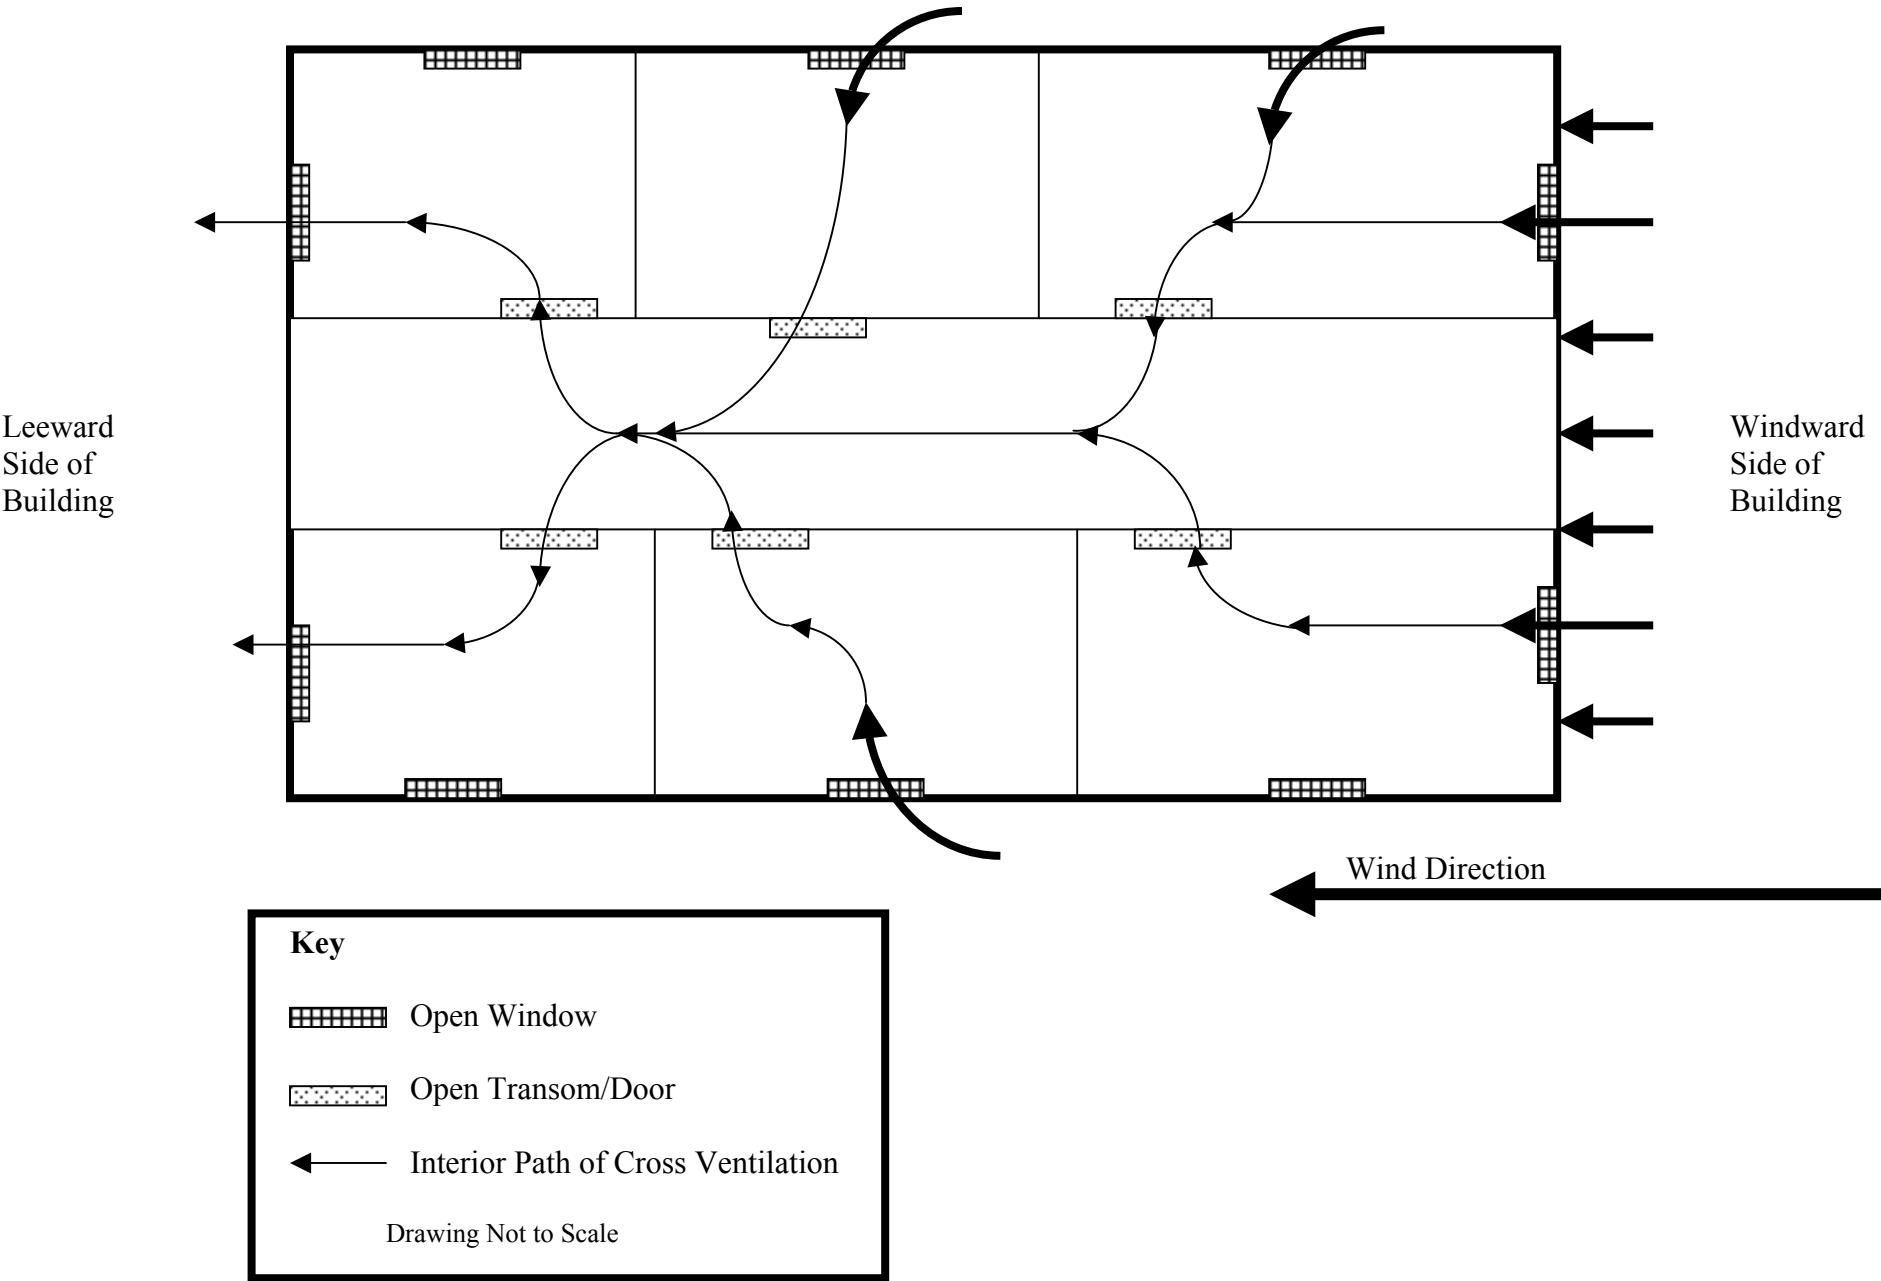
Figure 2

During summer months, ventilation was originally controlled by the use of openable windows in classrooms. The building was configured in a manner to use cross-ventilation to provide comfort for building occupants. The WTOB is equipped with windows on opposing exterior walls. In addition, hinged windows are located above the hallway doors. This hinged window (called a transom) enables the occupant to close the hallway door while maintaining a pathway for airflow. This design allows for airflow to enter an open window, pass through a room, pass through the open transom, enter the hallway, pass through the opposing room's open transom, into the opposing room and exit the building on the leeward side (opposite the windward side) (see Figure 2). With all windows and transoms open, airflow can be maintained in a building regardless of the direction of the wind. The system fails if the windows or transoms are closed (see Figure 3). Each room would have a long pole with a hook that was used to open the hoop latch

Cross Ventilation in a Building Using Open Windows and Transoms/Open Hallway Doors

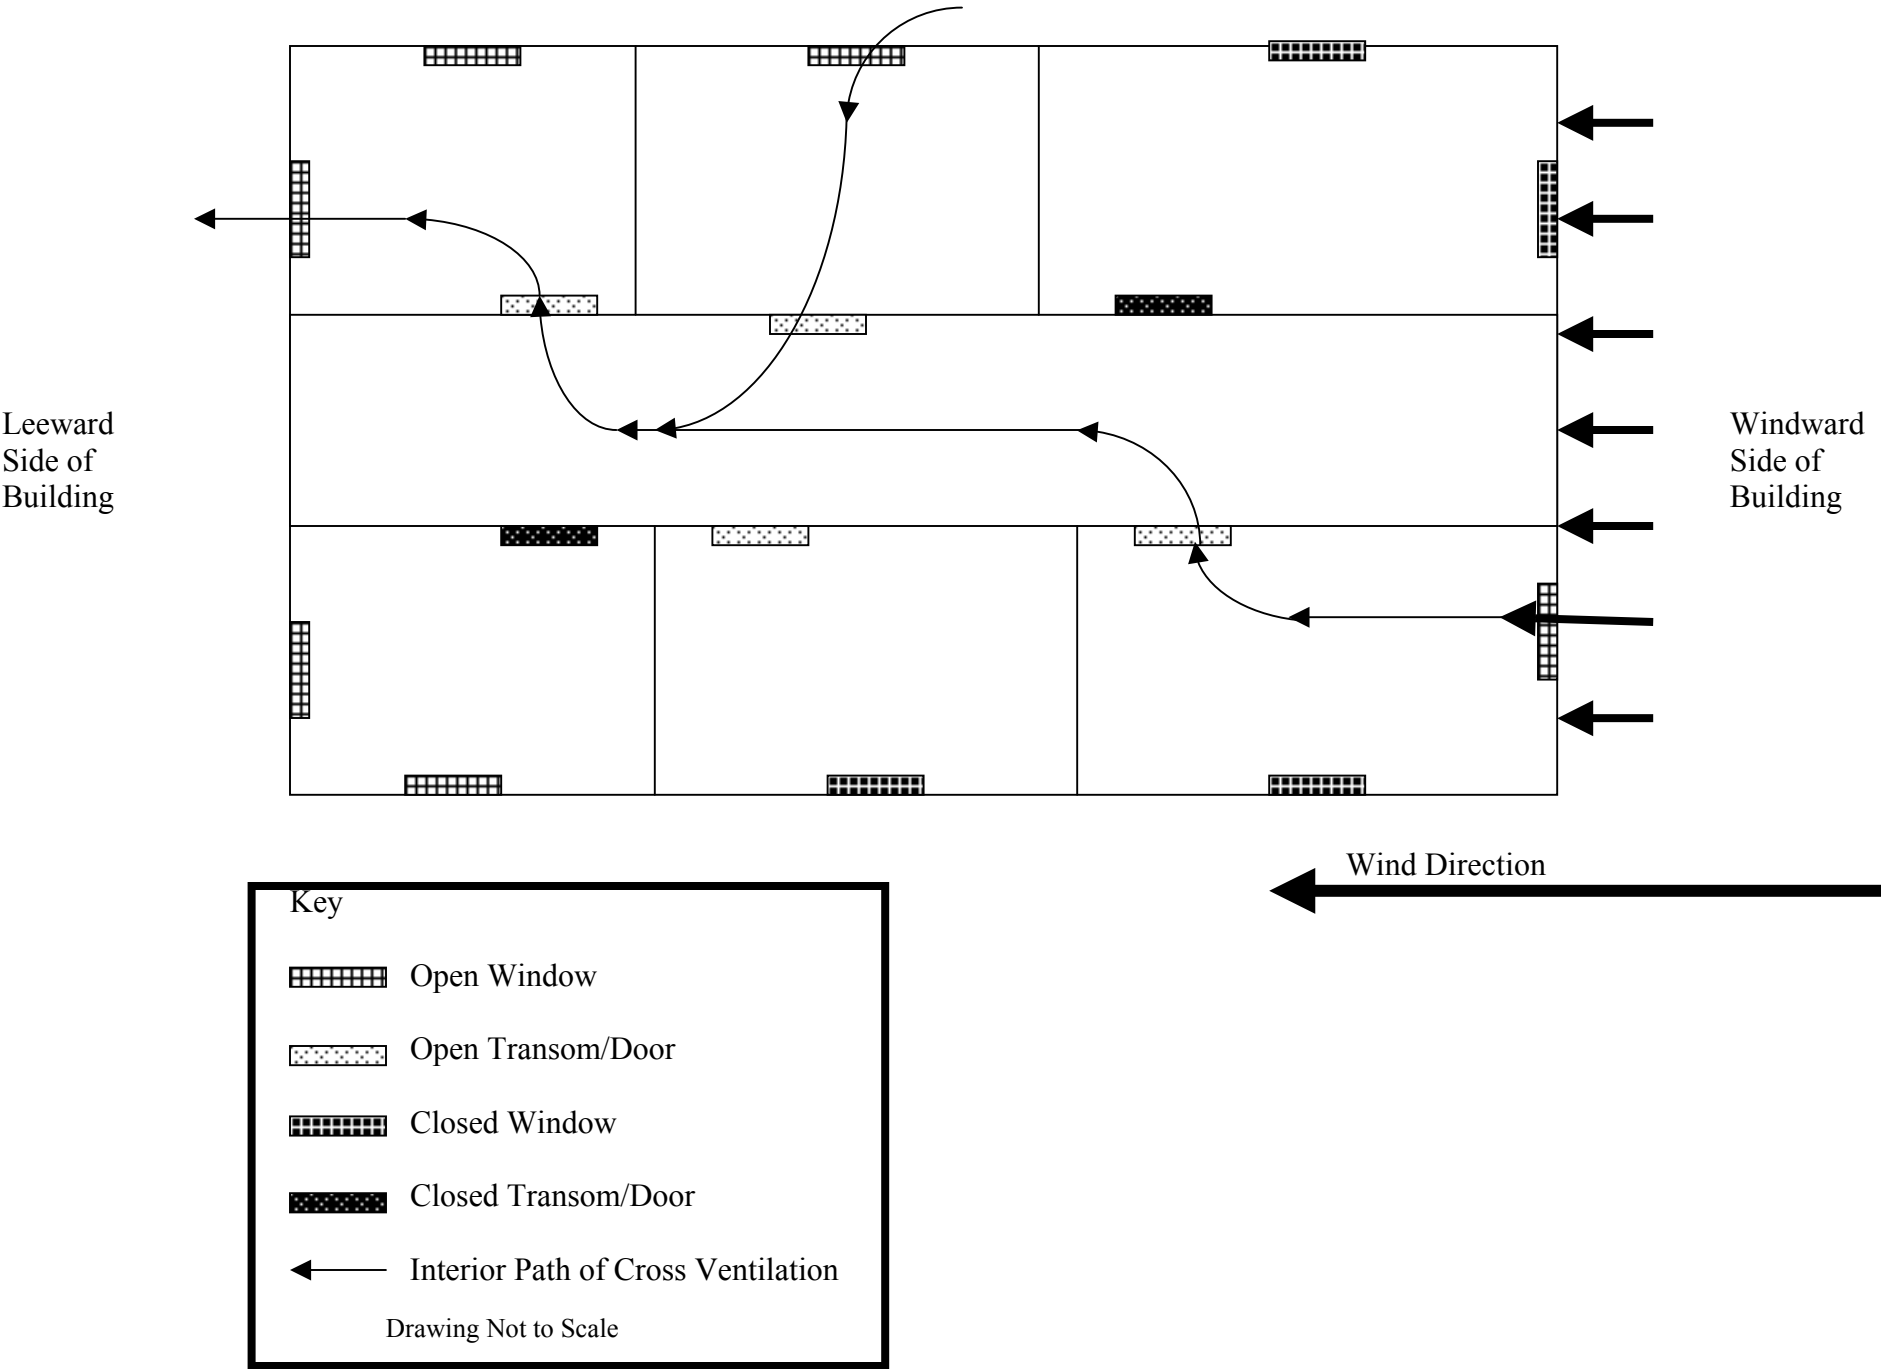
that locks the transom closed. Most transoms were permanently sealed during a previous renovation, which can inhibit airflow in the summer if hallway doors are closed. In addition, open windows may also allow for rainwater to penetrate through windows. Pests such as bats and insects also have access to the interior if windows are left open overnight (see **Other Concerns** section of this report).

Figure 3 **Inhibition of Cross Ventilation in a Building with Several Windows and Transoms/Open Hallway Doors**

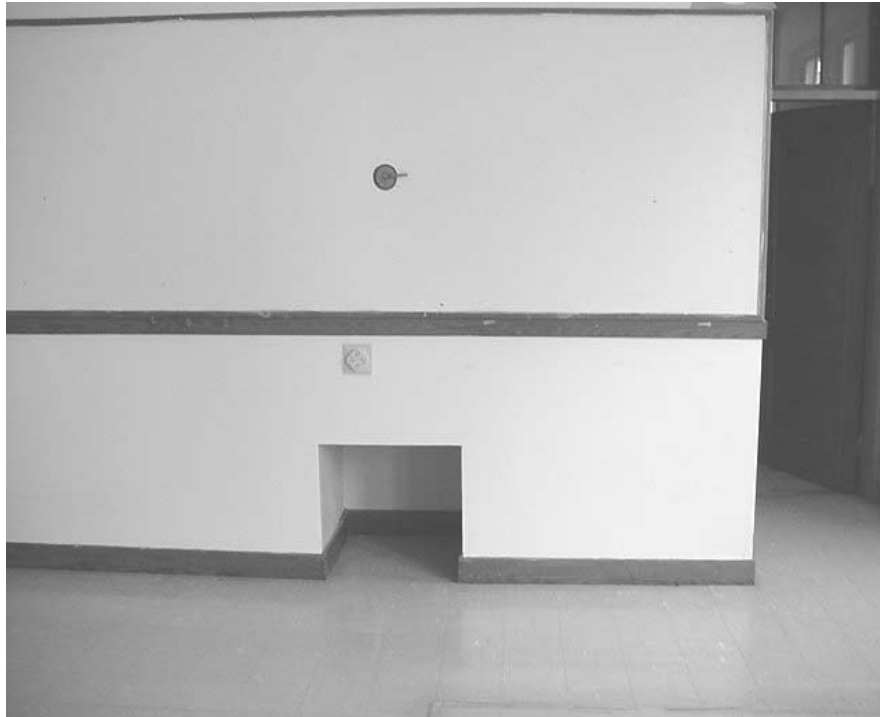
Picture 1

Exhaust ventilation is drawn from the classroom into an ungrated hole located at floor level (see Picture 1). No airflow was detected in any of the exhaust vents examined. A louver located inside the duct controls airflow. Above the louver is usually a heating element that creates airflow via rising heat called “the stack effect”. It is possible that

Exhaust Vent, Note Louver Lever Above Vent

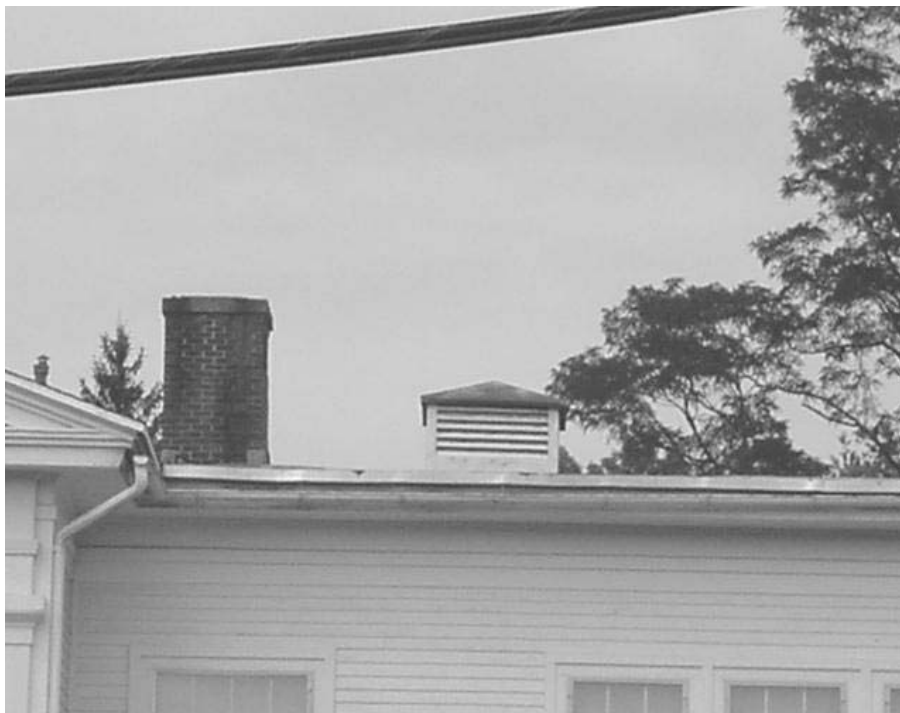
Picture 2

exhaust air is removed from the building by a deactivated fan/motor located in a cupola in the roof (see Picture 2). Examination of the ductwork in the attic found it cut in half and sealed with a plywood plug (see Pictures 3 and 4). The abandonment of the exhaust vents essentially prevents air from exhausting from the building. A potential source of odors is a restroom that was added on the first floor. It appears that the exhaust vent for this restroom was cut into the existing exhaust vent that was sealed in the attic. This configuration would direct exhaust air into the ductwork, which would then have the potential to migrate into town offices through existing exhaust vents when the restroom fan is activated. Under these circumstances, it appears that the building does not have a functioning exhaust ventilation system. Without exhaust ventilation, normally occurring environmental pollutants can build up and lead to air quality/comfort complaints.

Cupola On Roof, Note Lack Of Chimney Cap

- 7. Remove bats from attic/roof structures. Install bird screens on roof top cupola if missing. Install a roof cap on chimney to prevent bat entry.
 - 8. Seal all holes in the exterior walls of building to prevent mouse and other rodent migration.

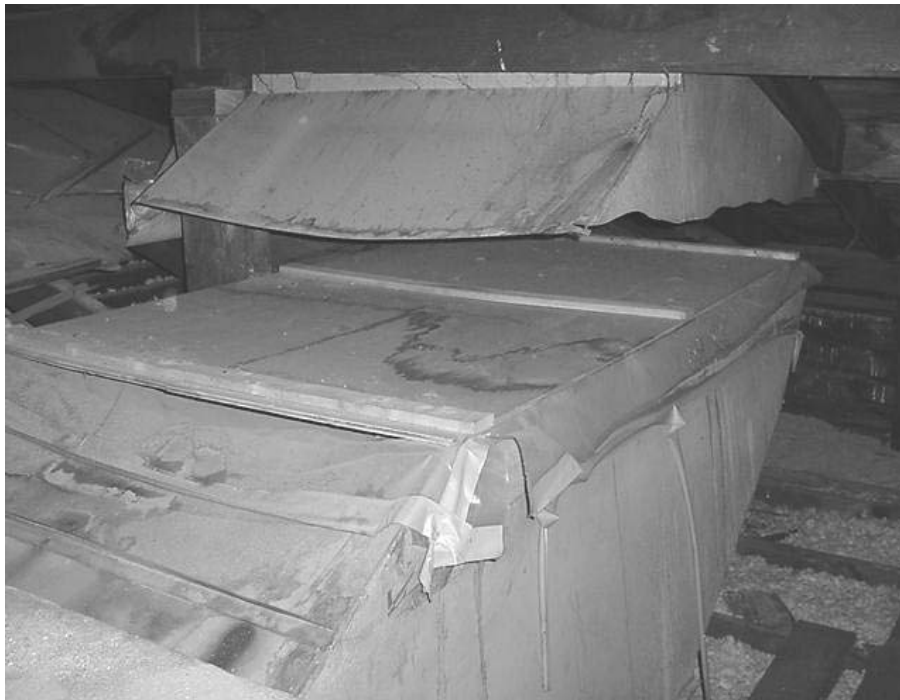
Picture 3

Duct Cut Apart And Sealed With Plywood

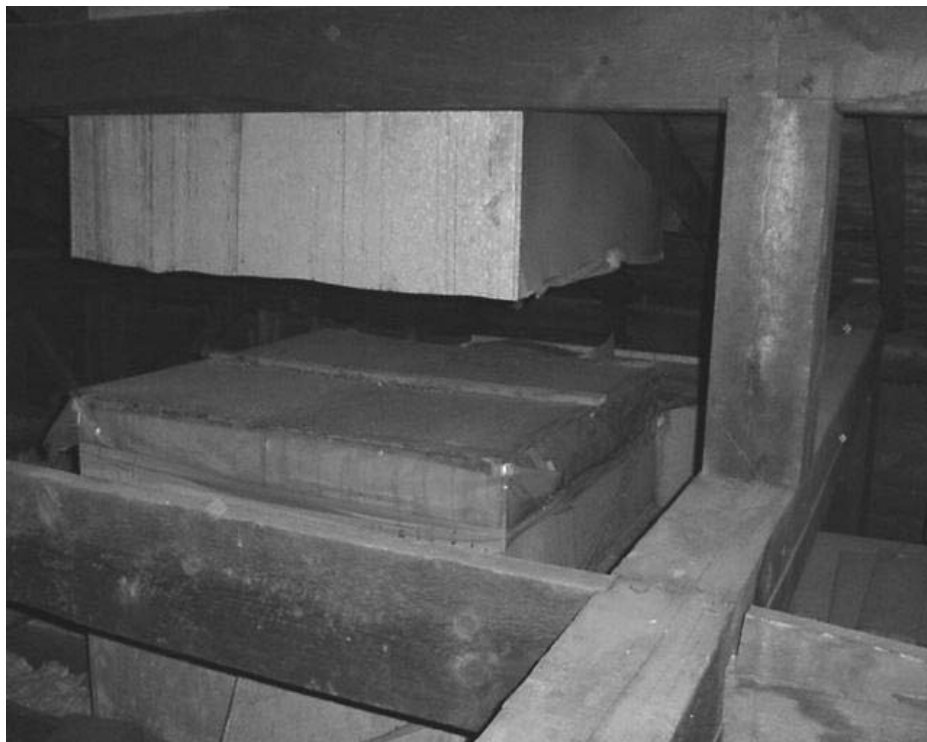
Picture 4

Duct Cut Apart And Sealed With Plywood

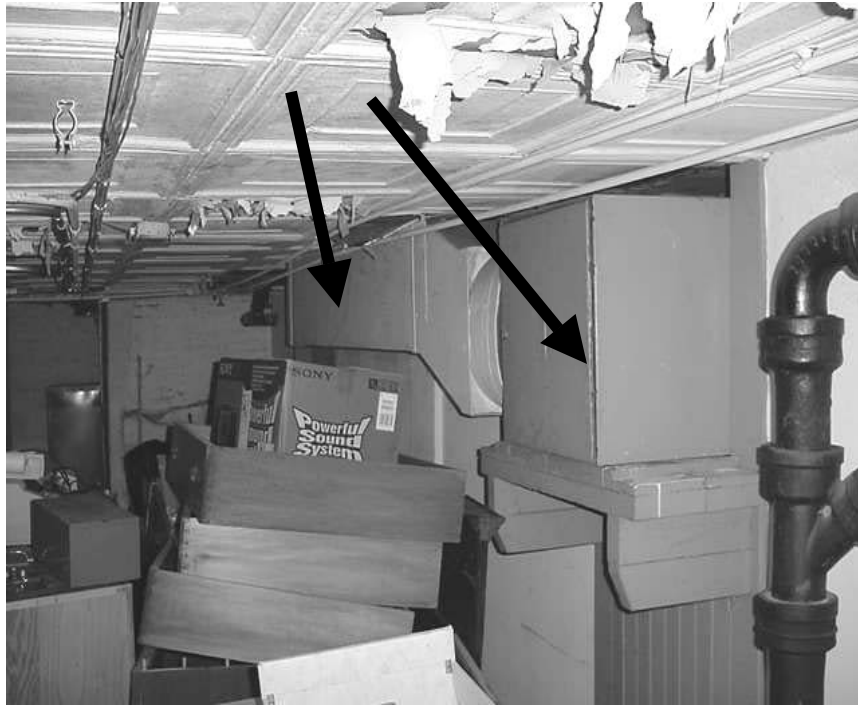
Picture 5

An abandoned exhaust ventilation fan system was located in the basement (see Picture 5). The purpose of this system originally removed odors and water vapor from the abandoned restrooms in the basement.

Restroom Exhaust Vent In Basement

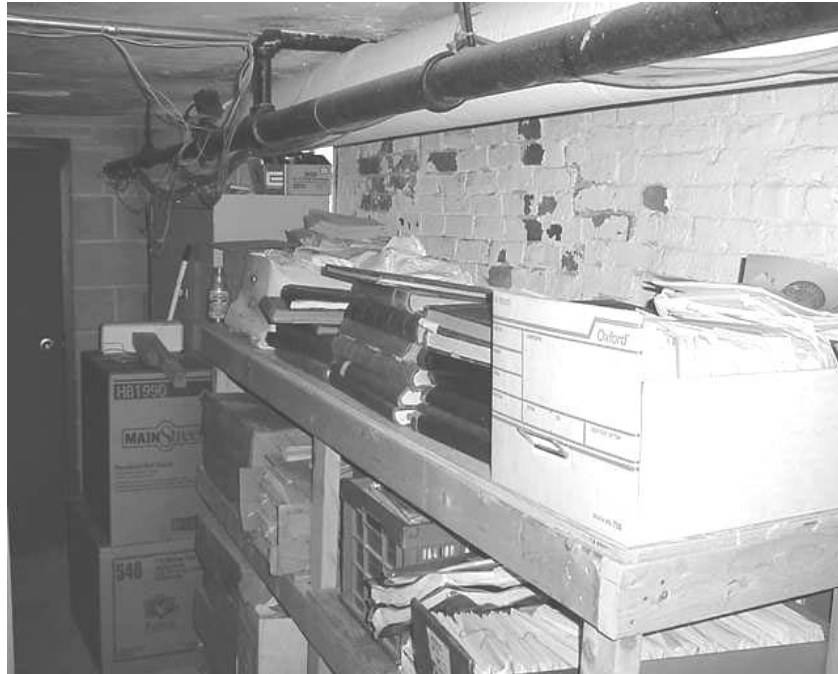
Picture 6

The basement is used for storage of large amounts of materials, including cardboard and paper products (see Picture 6). If these materials are subjected to high relative humidity conditions without drying for several days, it is likely that these materials can become colonized by fungi (mold). As noted previously, relative humidity measurements in the basement were 10 percent higher than the relative humidity measured outdoors (54%). Increased temperature indoors, as measured in this building, would be expected to have lower relative humidity compared to outdoors. The increase in relative humidity may indicate that a moisture source exists in the building. Several possibilities were examined:

Materials Stored In Basement

- 9. Remove mold colonized materials from the basement. Disinfect non-porous surfaces with an appropriate antimicrobial.
 - 10. Render airtight all holes/seams in univents.

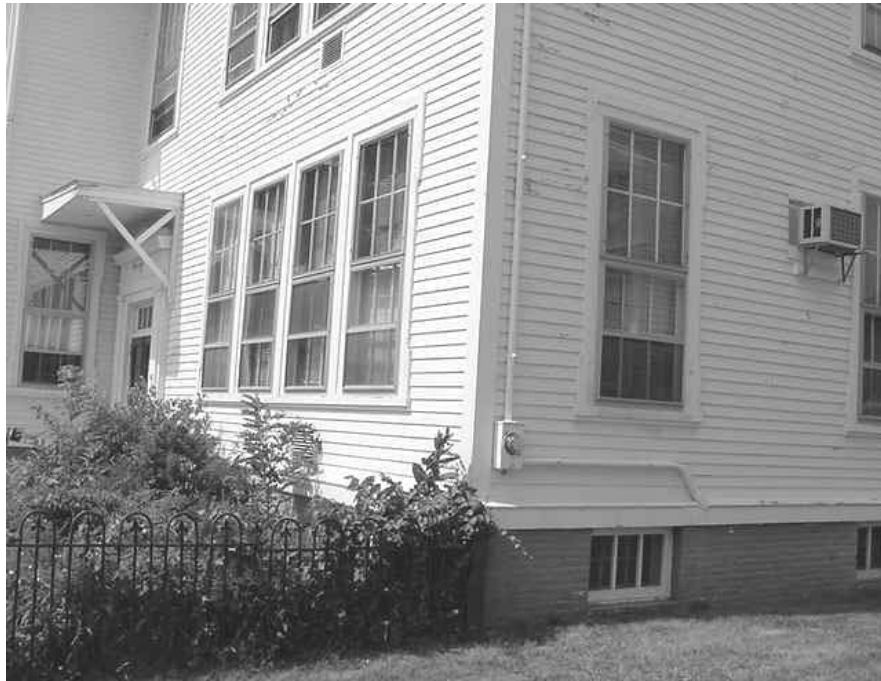
Picture 7

into the basement area must be minimized. Control of water penetration through the foundation can be limited by removing plants from close proximity to the exterior walls of the WTOB.

Shrubbery In Close Proximity To Basement

- a) Remove foliage to no less than five feet from the foundation.
 - b) Improve the grading of the ground away from the foundation at a rate of 6 inches per every 10 feet (Lstiburek, J. & Brennan, T.; 2001).

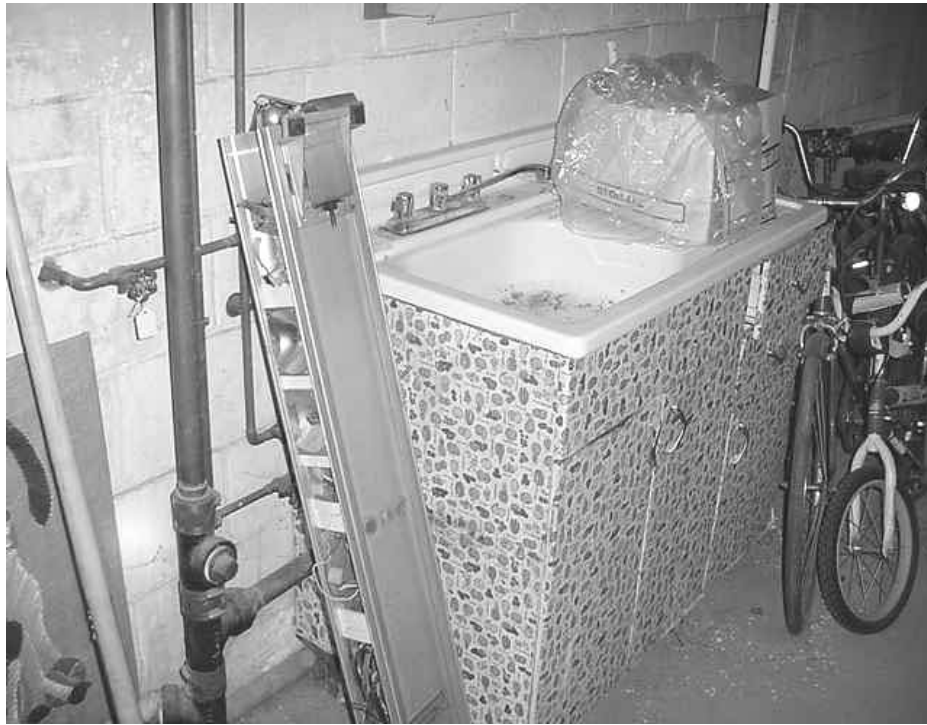
Picture 8

As previously mentioned, a number of former sinks/floor drains exist in the basement (see Picture 8). These drains did not appear to have recently drained water, which can lead to dry traps. A trap forms an airtight seal when water is poured down the drain. A dry trap can allow for sewer gas to back up into the building. These odors can then migrate up the stairwell in the same manner as described in the **Microbial/Moisture Concerns** Section of this report.

Abandoned Sink In Basement

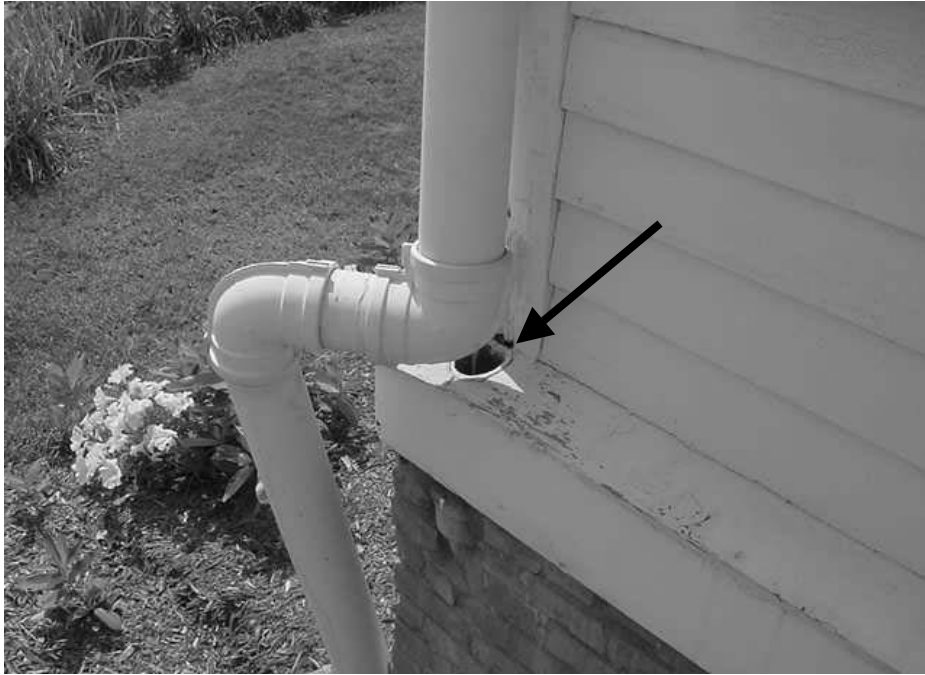
Picture 9

It appears that a new drainage system was installed for the roof gutters (see Picture 9) and that the original system was connected to pipes within holes in the exterior wall of the building (see Picture 10). Each original downspout drainpipe passes through the foundation and enters the floor of the basement (see Picture 11), presumably to the sewer/storm water system. If the air pressure within the sewer/storm water system increases due to a heavy water flow, odor can now be forced out from the original downspout system at ground level. Sewer gas can be irritating to the eyes, nose and

New Downspout Connection For Roof Drainage System, Note Hole For Pipe Of Original Downspout

1. Seal the original downspout pipes in the exterior walls of the building.
2. Keep the stairwell door to the basement closed. Install weather stripping and a door sweep on this door to create an airtight barrier.
3. Seal all abandoned drains in the basement. Disconnect water supplies to sealed drains.
4. Repair the restroom exhaust vent system in the basement. Once repaired, operate the system to remove water vapor from the basement.
5. Ascertain whether the first floor restroom vent is connected into the general exhaust vent system. If connected to the general exhaust system, disconnect to prevent odor migration throughout the building. If connected to the duct for the basement restroom vent, leave this connection intact.
6. To prevent moisture penetration into the basement, the following actions should be considered:

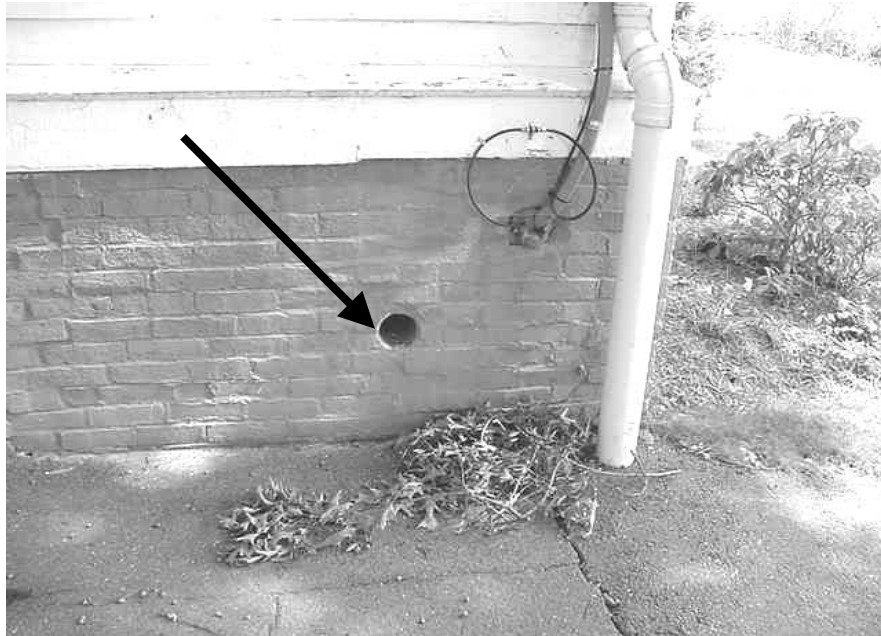
Picture 10

Hole For Pipe Of Original Downspout In Foundation

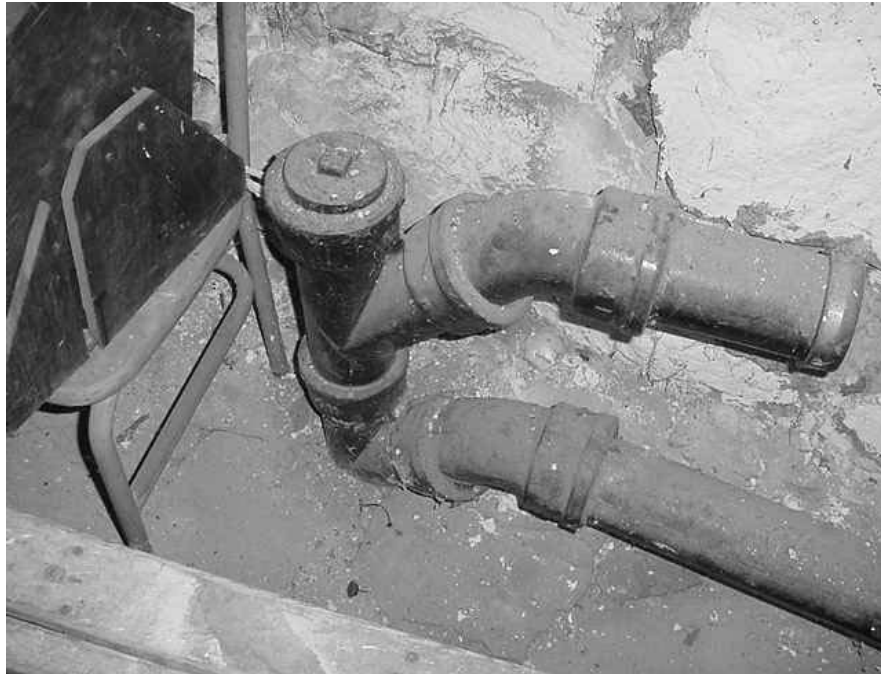
Picture 11

throat. It is possible that both the basement drains and the original downspout system can emit odors, particularly during or after rainstorms.

Pipes In The Basement Connected To Original Downspout System
